## **Features of Environmental Issues Related to Abandoned Mining Exploitations in Albania**

A. Halili<sup>1</sup>, G. Muka<sup>2\*</sup>

**Abstract:** Abandoned mining exploitations, which include all the workings, related to the mine opening, preparation and exploitation as well as all the consequences of the mining activity after its completion, require constant attention in order to avoid or minimize their damaging impact on both the environment and the human activity. Previous research has dealt with the methods related to assessment of the susceptibility, vulnerability and the geo-risk in the abandoned exploitations and has recommended concrete technical, administrative and constructive measures to deal with the geo-risk in urban planning and land use in order to provide an appropriate environment not only for humans but also for flora and fauna in general. The interest of researchers begins with recognizing the problem, continues with the involvement of influential factors in the building of the evaluation model and ends with the methodological recommendations that should be implemented to avoid or reduce harmful impacts. In this paper are treated the features of environme

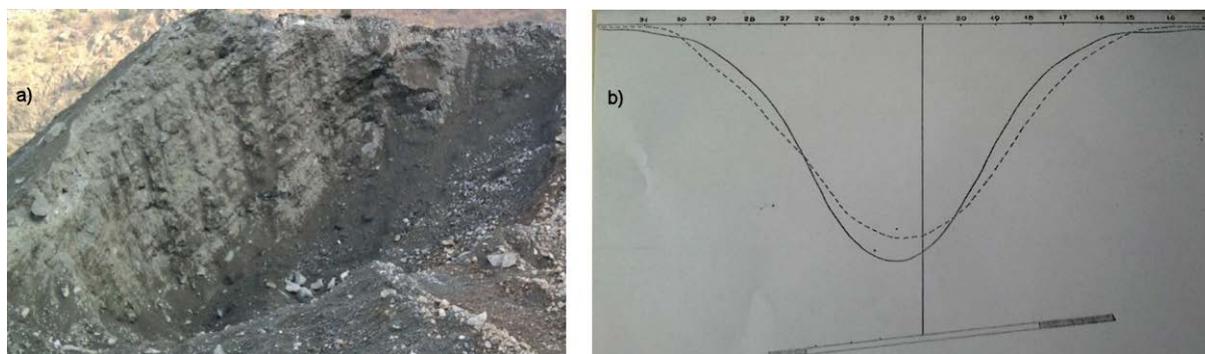
**Figure 1. a)** Funnel on the soil surface, Bulqizë (Muka, *et al.*, 2014) **b)** Subsidence curve, mine of Valias (Zoto, 1987)

This phenomenon takes different forms depending on the geological conditions, physical and mechanical properties of the rocks in the roof of the exploited area, as well as on the technical and mining conditions of the exploitation (exploitation depth, exploitable thickness, the size of the ore body, etc.) (Muka., 1989, Arapi *et al.*, 2014, Zoto, 1987). In the case of metal ore bodies (chromite, copper), the phenomenon is expressed in the form of funnels, sinkholes and landslides (Muka *et al.*, 2014).

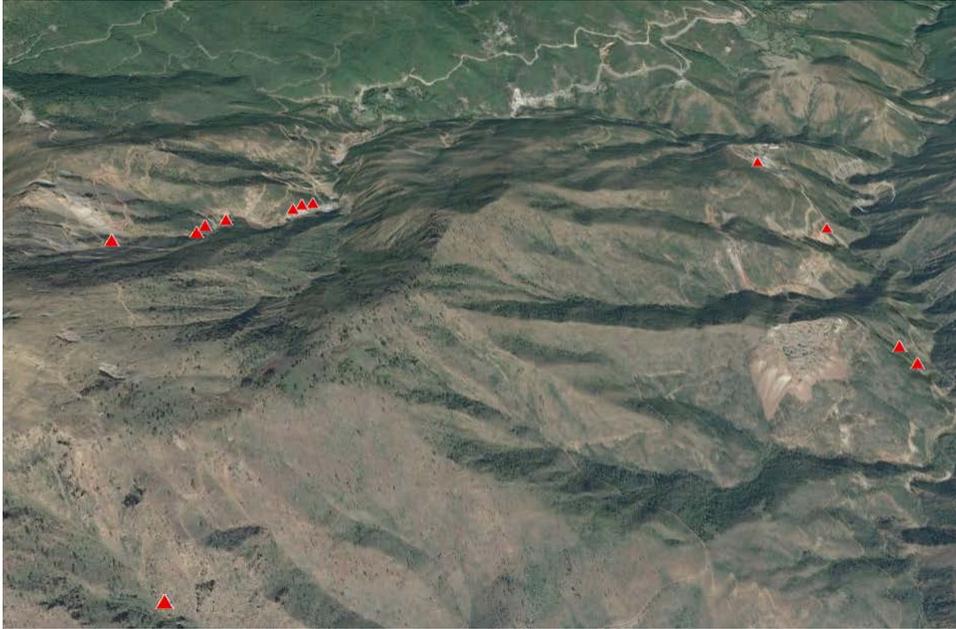
**Figure 2.** Entry to the abandoned workings in the chromite mine of Kalimash-Kukës

In Albania, the minerals of chromite, copper and iron-nickel are located in the mountainous regions. Figure 2 shows the regionalization of a chromite mine (Kalimash-Kukës).

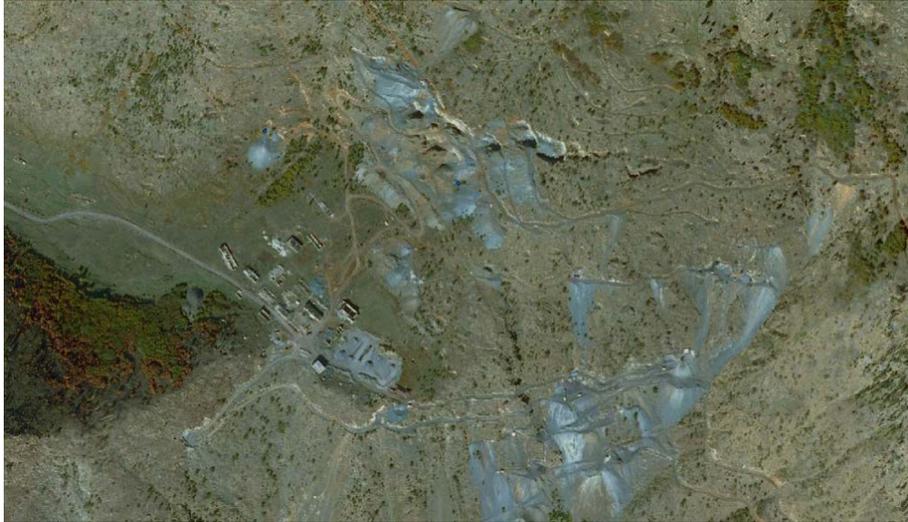
**Figure 3.** Image of the abandoned exploitations in the chromite mine

The coal mines present a different scenario. In most cases these areas were close to the urban activity. Therefore, all projects regarding technological in situ objects, reserves of sterile materials, and the mining workings were drafted while taking into consideration the environmental impact. Nevertheless, even in these cases, after the cessation of mining activity, no measures were taken in eliminating or minimizing the negative effects of the abandoned exploitations on the environment (Figures 3&4).

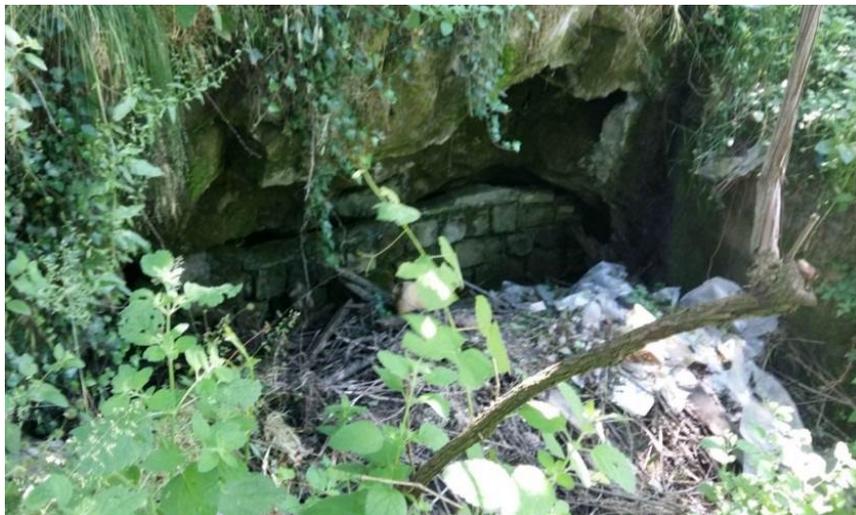
**Figure 4.** Image of the "sealed" entry of an abandoned exploitation

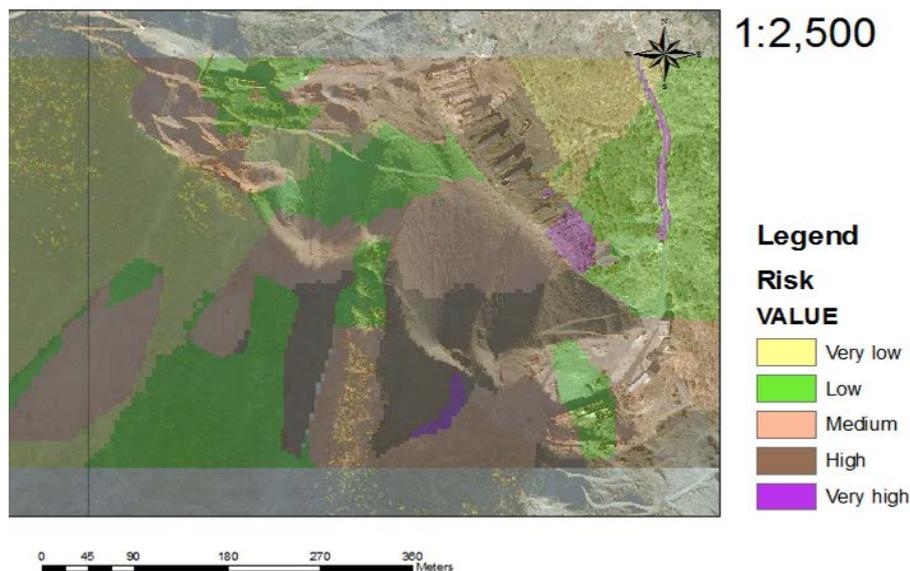
**Figure 5.** Mapping of georisk – southern Bulqiza mine

At the current stage have been studied the conditions of stability of underground openings and their impact in the ground surface (Muka G., 1989), the assessment and regionalization of susceptibility (Muka G., 2016), determined the degree of vulnerability of buildings and other objects in vulnerable areas (Muka G., *et al.*, 2014) and is assessed and regionalized the geo-risk. Figure 5 illustrates the mapping of the geo-risk for the vulnerable area in the chromite mine of Bulqiza (Muka G., 2016). Despite these results, there is still no national mapping of the geo-risk regionalization, which would be used in drafting more efficient measures to avoid or minimize the dangerous impact and to rationally use the soil.

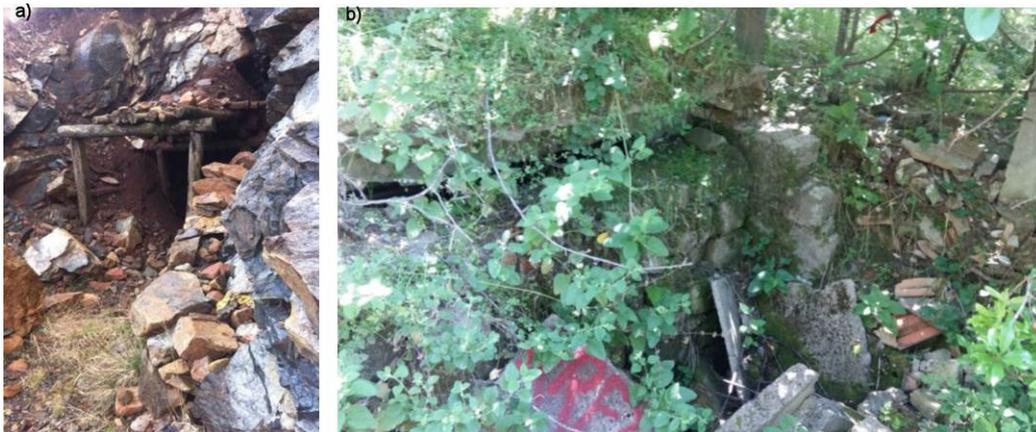
**Figure 6.** a) Unsealed entry of an abandoned exploitation in the chromite mine of Bulqiza b) A ‘formally’ sealed entry in the coal mine of Krrabë

The environmental issue in this case is linked with putting at risk the life of people and other living creatures because many open entries are not sealed (Muka, *et al.*, 2014). As such, they become easily accessible to people who are in need (people who want to extract materials as rails, wagons, ventilation tubes, timber used for roof or wall support, etc.), wanderers (such as shepherds or passers-by), young children or other living creatures that are not aware of the risk. As such, by accessing the working site, and sometimes due to any disturbance caused by them, the workings may collapse resulting in injury or death of the ‘visitors’. Accidents like this have happened (Botasot.info, 2013) and no preventive measures have been taken. Figure 6a illustrates the unsealed entries of an abandoned exploitation in the chromite mine of Bulqiza, while Figure 6b illustrates a ‘formally’ sealed entry in the coal mine of Krrabë, which has recently caused the death of two people (Cemeta, 2016). In the meantime, several attempts have been made in mapping the problems related to the entries of the abandoned exploitations (Muka, *et al.*, 2014, Cemeta, 2016), but no measures have been taken in order to avoid the dangers they bring. A complete project regarding the measures to be taken should start with a detailed and thorough identification of open entries, because there are no records on the issue (Muka, *et al.*, 2014).

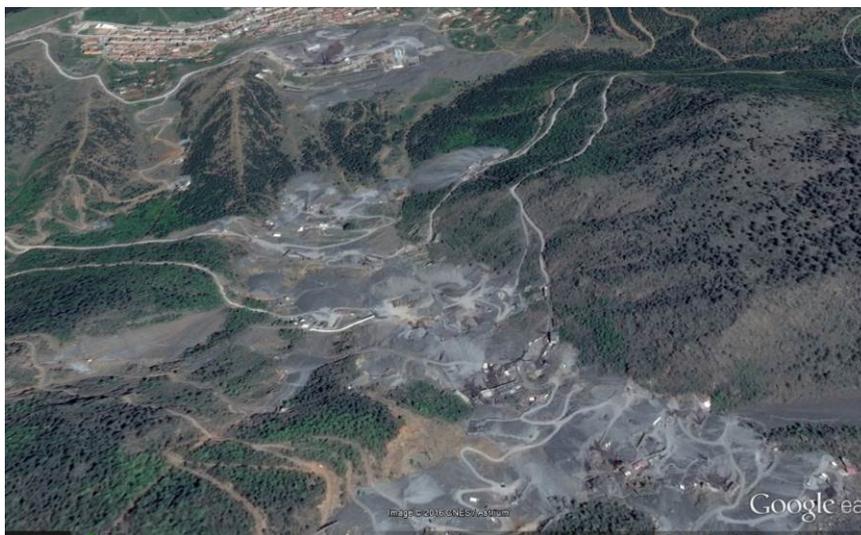
**Figure 7.** A “dent” in the territory due to the sterile stocks in the chromite mine of Bulqiza

The exploitation of useful minerals requires the construction of several technological and operational objects in the mining site. No project regarding the environmental impact was implemented for building such objects. The basic principle applied was minimizing costs. Figure 7 illustrates the fact that many objects, mainly the operational ones, were built within the area of sterile rock dumps. Because of this, and due to the fact that they were in a dangerous area under the influence of underground mining exploitation and consequently affected by it, the objects were declared useless and their relocation was required (Arapi, 2014). After being abandoned, and with no land rehabilitation projects in place, such objects are still standing in ruins. Figures 9a and 9b illustrate this grim scene. The environmental issue of the abandoned objects is related to:

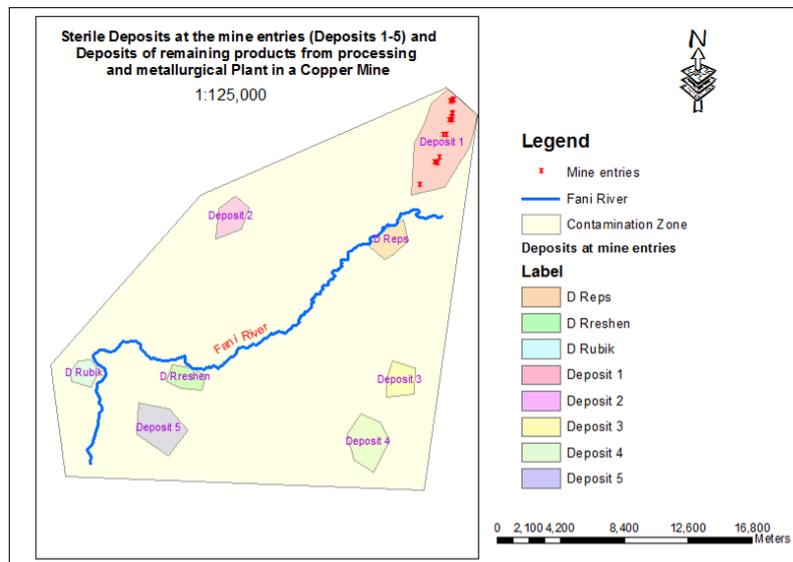
**Figure 8.** Sterile deposits with harmful content in the territory of a Copper Mine

Figure 8 illustrates the sterile dumps near the mine entries, the waste from copper enrichment and from metallurgical processes, and the land spreading of the harmful elements (region of Mirdita) by regionalizing the contaminated surface, whose area is estimated as 500 km<sup>2</sup>. The deposits 1 to 5 consist of small deposits, which are located at the open entries of underground mining exploitations. Therefore Deposit 1 consists of 17 smaller sterile dumps. The deposits at Fan River (D Repts, D Rreshen and D Rubik) are waste deposits from the processing plants, mainly metallurgical ones. The stocking of such deposits was not handled in compliance with the standards for environmental preservation, so its impact on the environment and on the river’s fauna is very harmful.

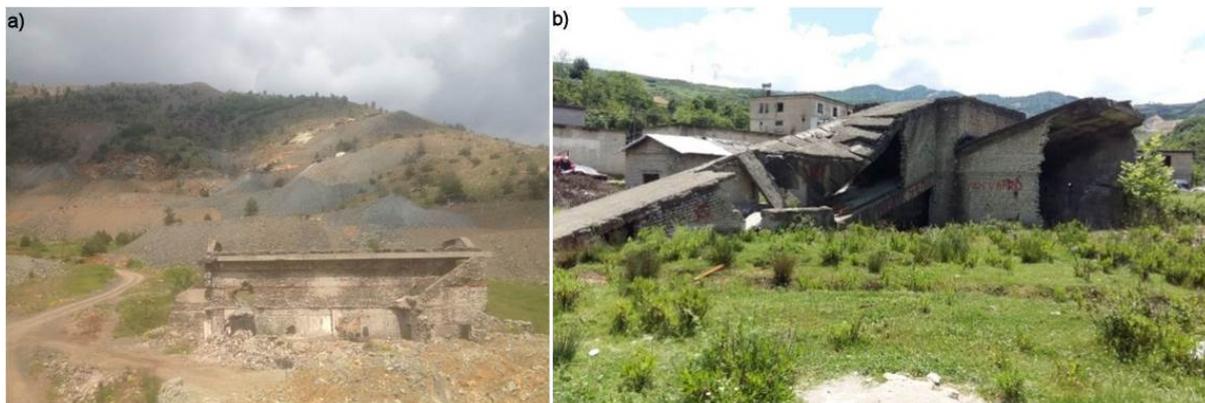
**Figure 9.** Images of abandoned objects a) at a chromite and b) a coal mine (Cemeta, 2016)
