## Relative Rate of Durability towards Influence of Water in Stone Degradation: Case Study of Lead Mosque in Shkodra (northwest Albania)

**Abstract:** The Lead Mosque is located in the northwest of Albania into a humid Mediterranean environment. It was built in 1773 by the Albanianpasha Mehmed Bushati who was vizier of Shkodra at the time. Through this act, he intended to give his city of birth, the feeling of the capital. The mosque has numerous cultural importances and represents a building built with calcareous stone based materials which have suffered degradation process due to long exposure periods to the existing environmental conditions. The main purpose of this paper is to present the influence of water and relative humidity on stone degradation. Water circulation in stones and water flow between stones and atmosphere or ground are one of the main driving factors in the building degradation processes in other historical monuments of Albania including other religious. It is well known that porous building materials absorb and desorbs water as a function of the weather conditions (temperature, relative humidity, and rainwater), that is why water plays a fundamental role in t

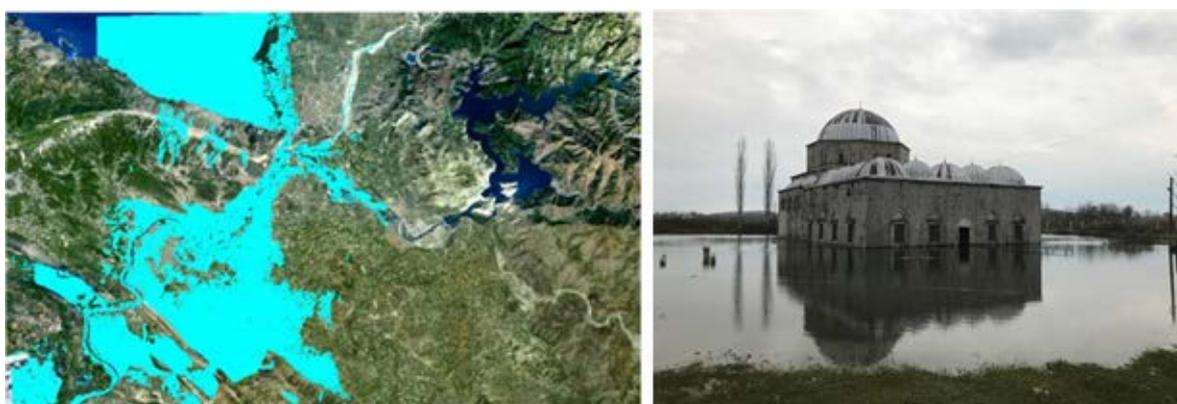
**Figure 2.** The flood area and flooded Lead mosque 24<sup>th</sup> March 2018

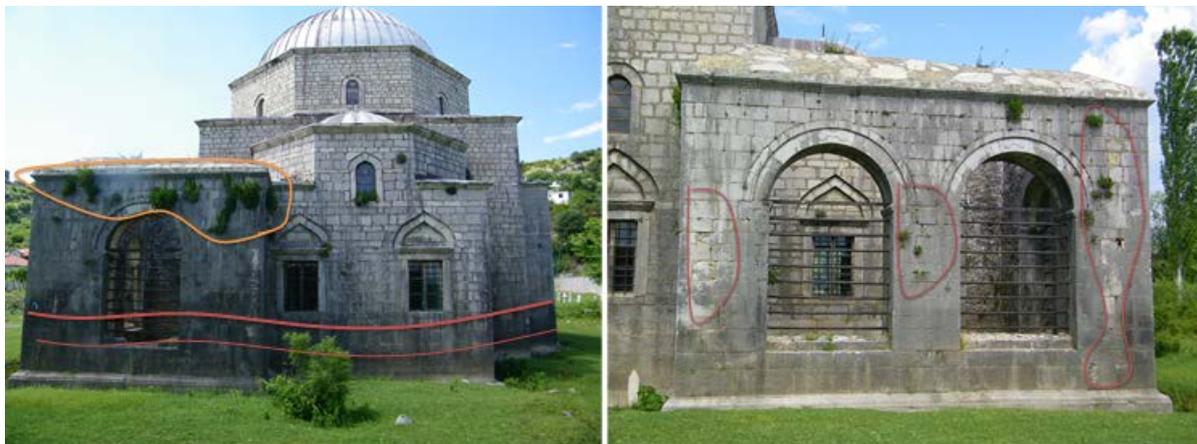
**Figure 4.** Traces of weathering factors influence and acceleration biological degradation in Lead Mosque

The increased values of precipitation, relative humidity and temperature oscillations are evidenced during site visits (Figure 4), while these weathering factors are directly influencing in an accelerated biodegradation. On entire wall structure clearly there are two phenomenons: heavily damaged wall and connection sites, and secondly bio-invasion one.

As a conclusion, it can be confirmed that this monument is seriously threatened by the weathering factors and there is limited maintenance effort. In order to preserve it is an urgent need to: (i) undertake a rehabilitation plan with clearly defined measures; (ii) mitigation measures against the flood has to be considered as an integral part of the wider area; (iii) mosque mitigation measures has to be designed
